## **MARINE SAFETY ALERT**

### **Remain Upright by Fully Understanding Vessel Stability**

## Improving Fishing Vessel Stability

### **SCANDIES ROSE Stability Analysis with Asymmetric Crab Pot Icing**

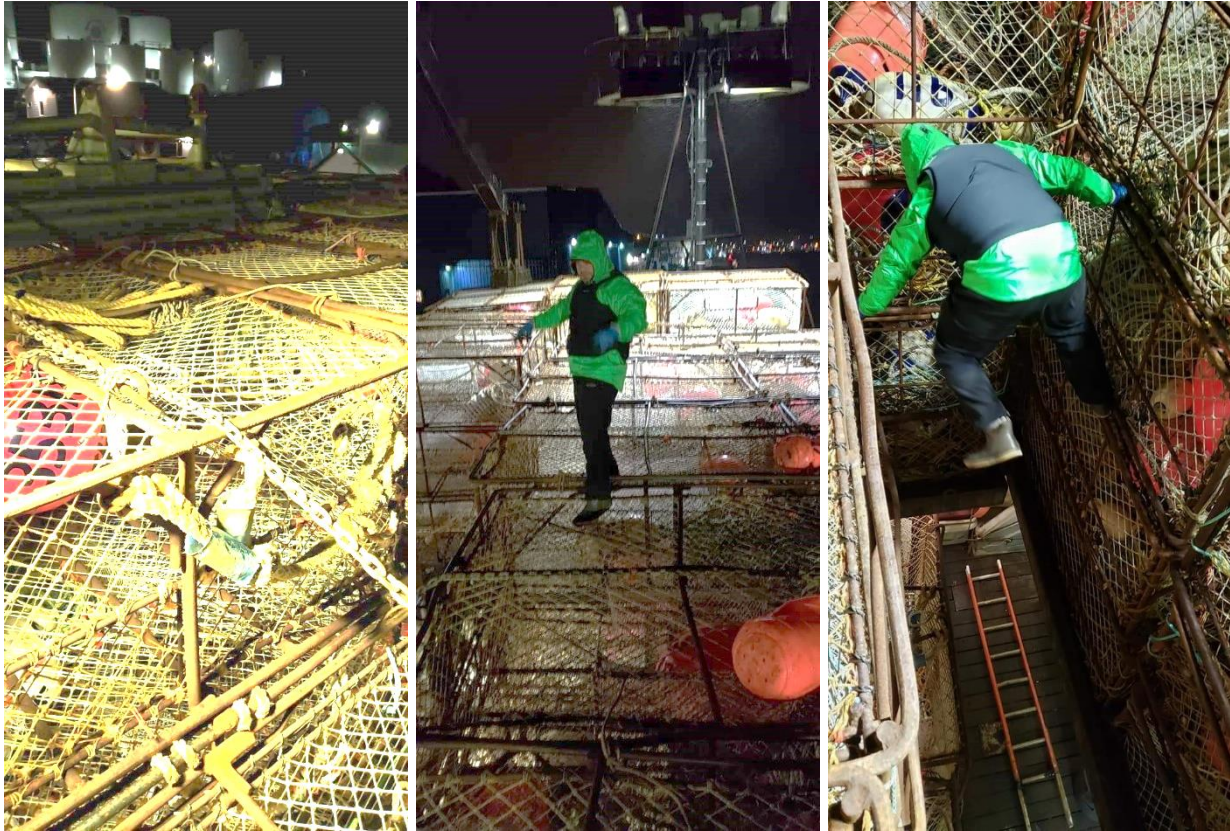
The Marine Board of Investigation indicated that actual crab pot load distribution was as shown in Figure 1 for the casualty voyage. Because Figure 1 does not show the full extent of crab pot loading, Figure 2 was used to indicate the typical way that crab pots are loaded aboard SCANDIES ROSE. During the casualty voyage, asymmetric ice accumulation on crab pots was reported on the starboard bow, from amidships forward.

Figure 1: Pictures of Crab Pot Loading from Casualty Voyage (provided to MSC by Marine Board of Investigation)

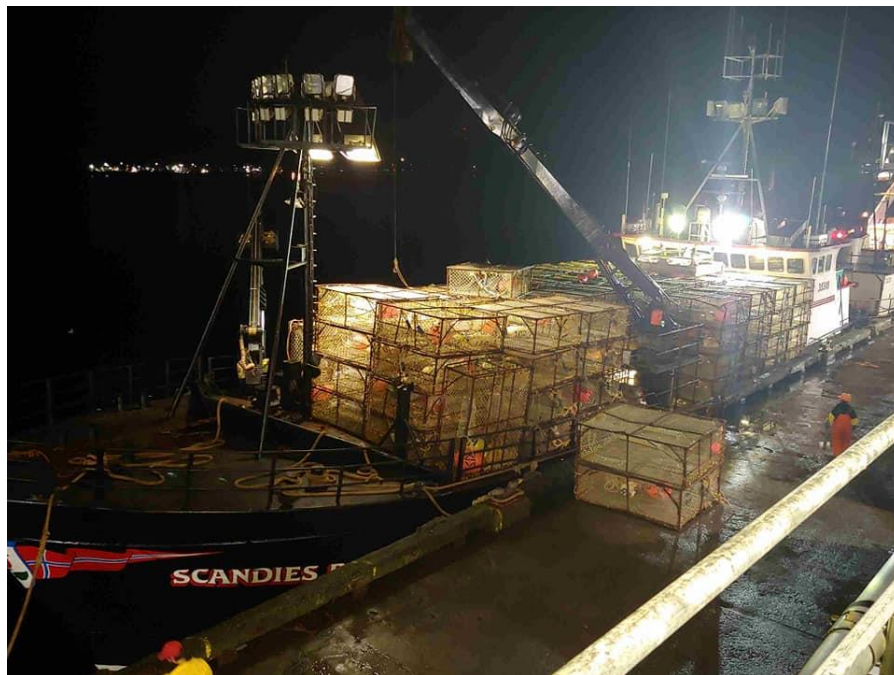
Figure 2: SCANDIES ROSE Crab Pot Loading from Unidentified Voyage. Assumed to be Typical Crab Pot Loading (Provided to MSC by Marine Board of Investigation)

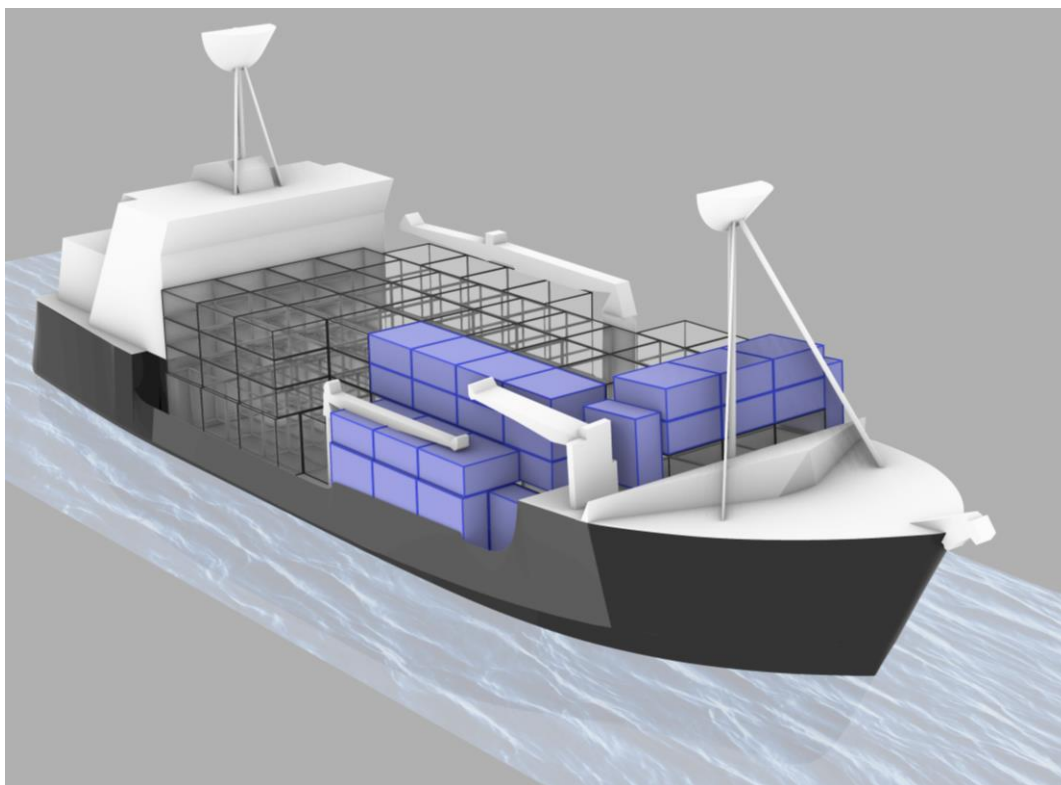
To evaluate asymmetric icing of crab pots on the starboard bow, MSC applied ice only to the exposed crab pots on the starboard side, forward of amidships and exposed forward extent of the stack. This results in 24 crab pots experiencing icing as shown in Figure 3. The initial hydrostatic condition of the computer model with the assumed loading is shown in Figure 4 and Figure 5.

Figure 3: Graphic representation of MSC model with 195 crab pots loaded and 24 exposed crab pots on the starboard bow affected by ice (shown in blue)

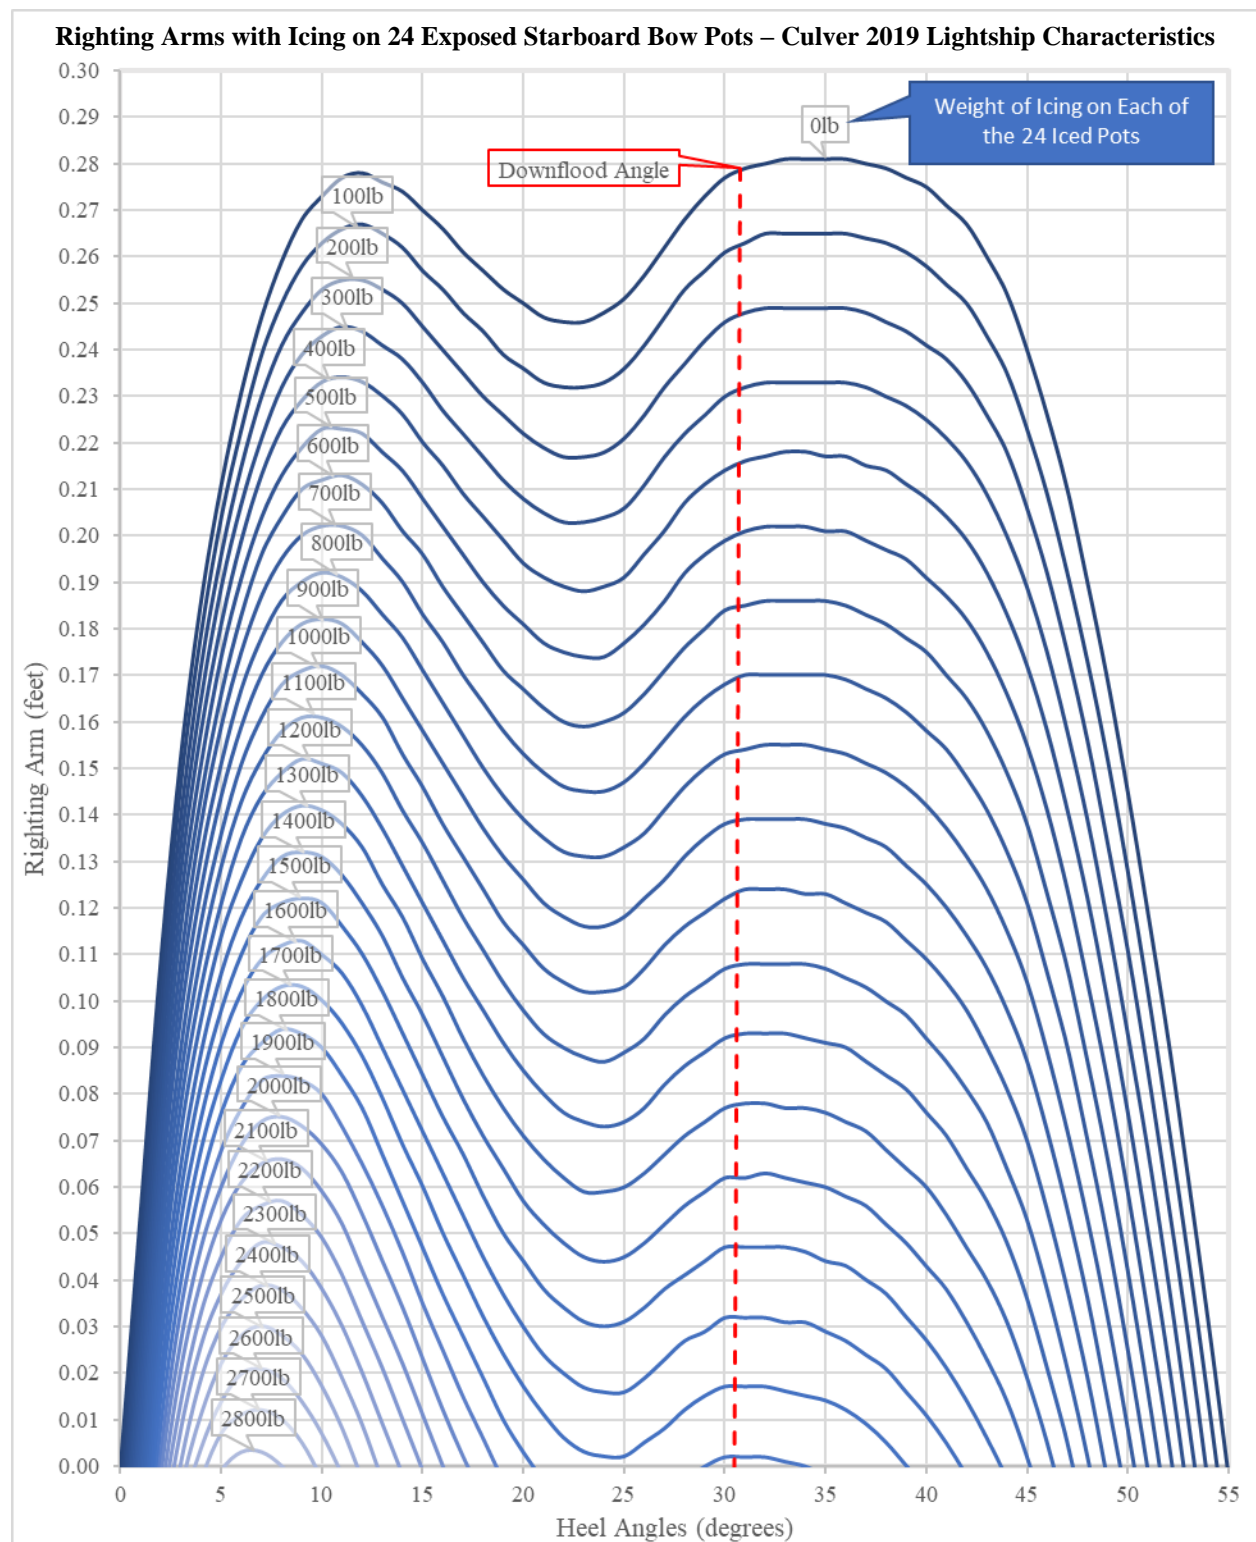
Depending on the lightship characteristics used, MSC's hydrostatics model with the assumed casualty loading condition indicated capsize with 1,800 to 2,900 lbs. of ice on each of the 24 exposed starboard bow crab pots as shown in Figure 6 and Figure 8.

Figure 6: Righting arm plots with increasing ice weights for the 24 exposed crab pots on the starboard bow using Mr. Culver's provided lightship characteristics from 2019

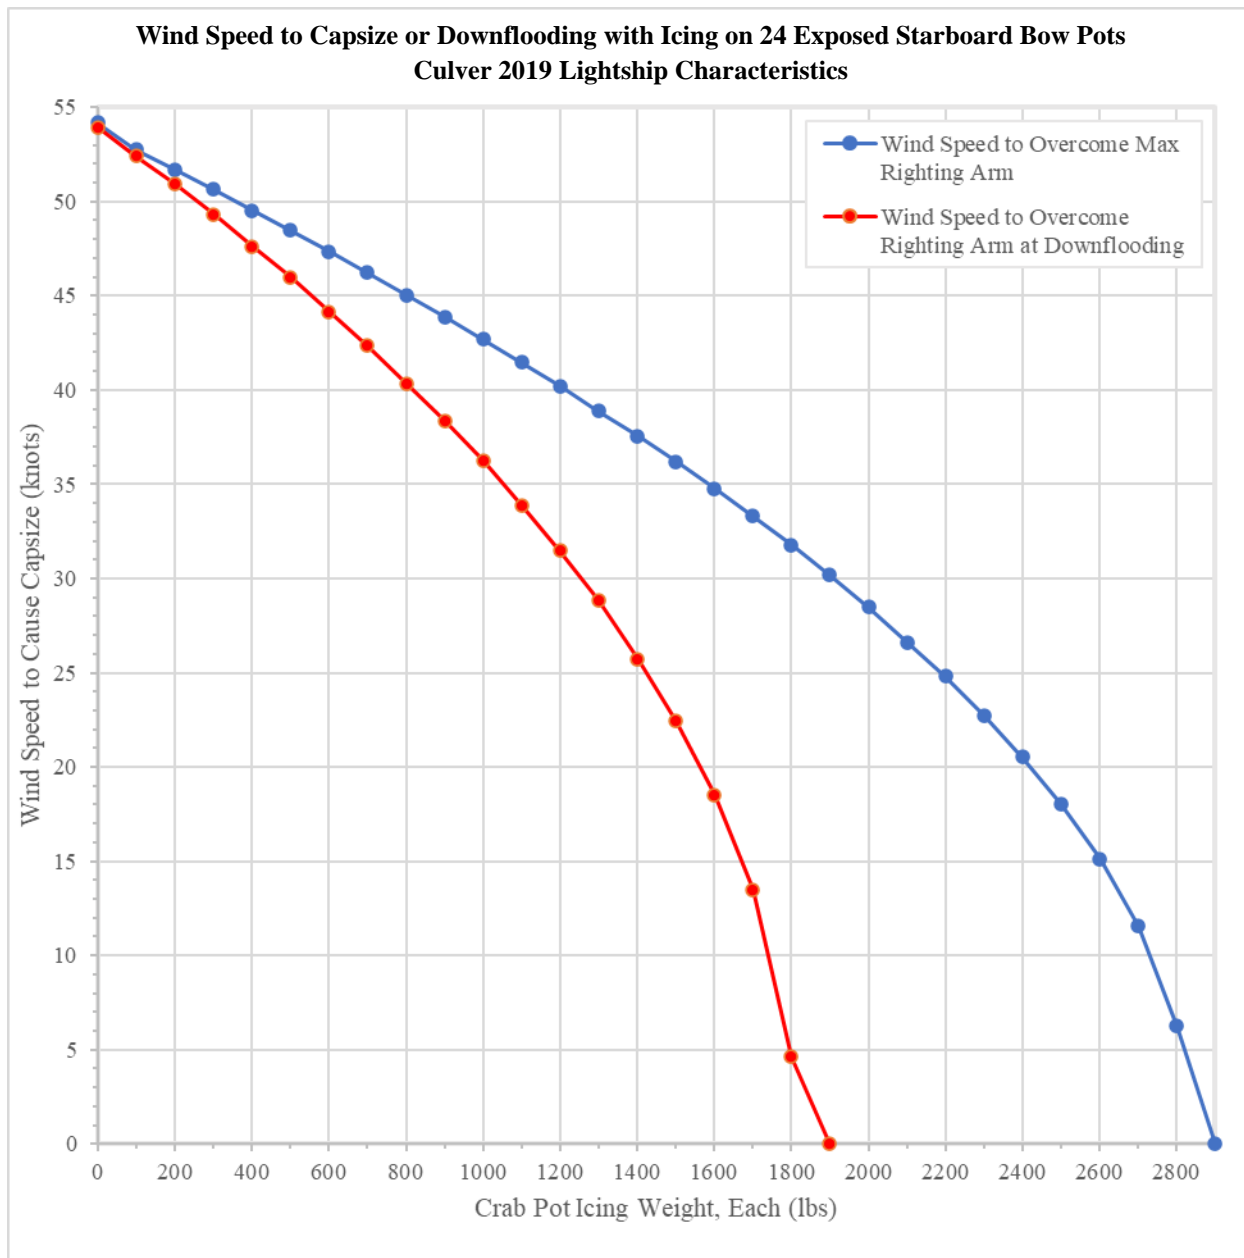
Because ice formation is coupled with wind speed, MSC also evaluated the wind speeds at which capsize or downflooding would occur with asymmetric icing as shown in Figure 7 and Figure 9. It is important to note that the model indicates SCANDIES ROSE has low righting energy in the loaded condition (as shown in ref. (a), page 88) and capsize is indicated with wind speeds as low as 39 knots with no pot icing.

Figure 7: Wind speed to cause capsize or downflooding vs. crab pot icing weight on 24 exposed starboard bow pots using Mr. Culver's provided lightship characteristics from 2019

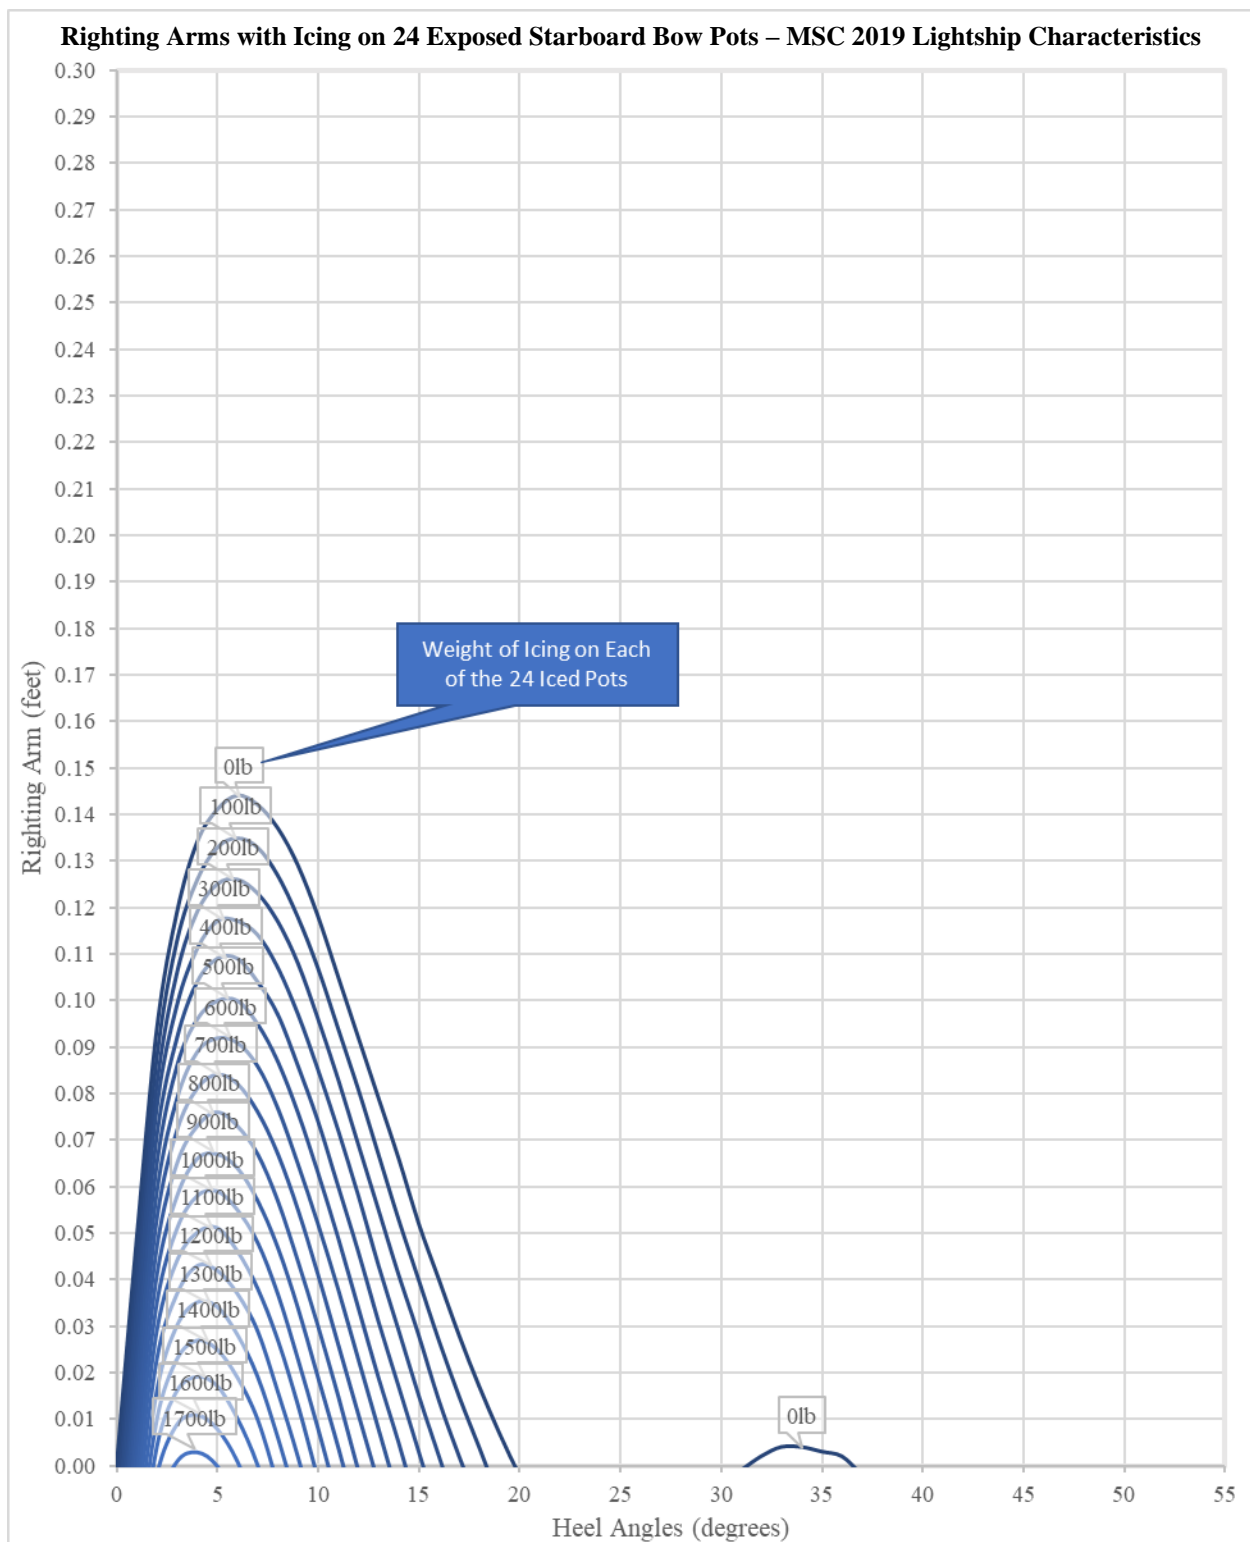
Figure 8: Righting arm plots with increasing ice weights for the 24 exposed crab pots on the starboard bow using MSC's calculated lightship characteristics from Mr. Culver's 2019 stability test notes

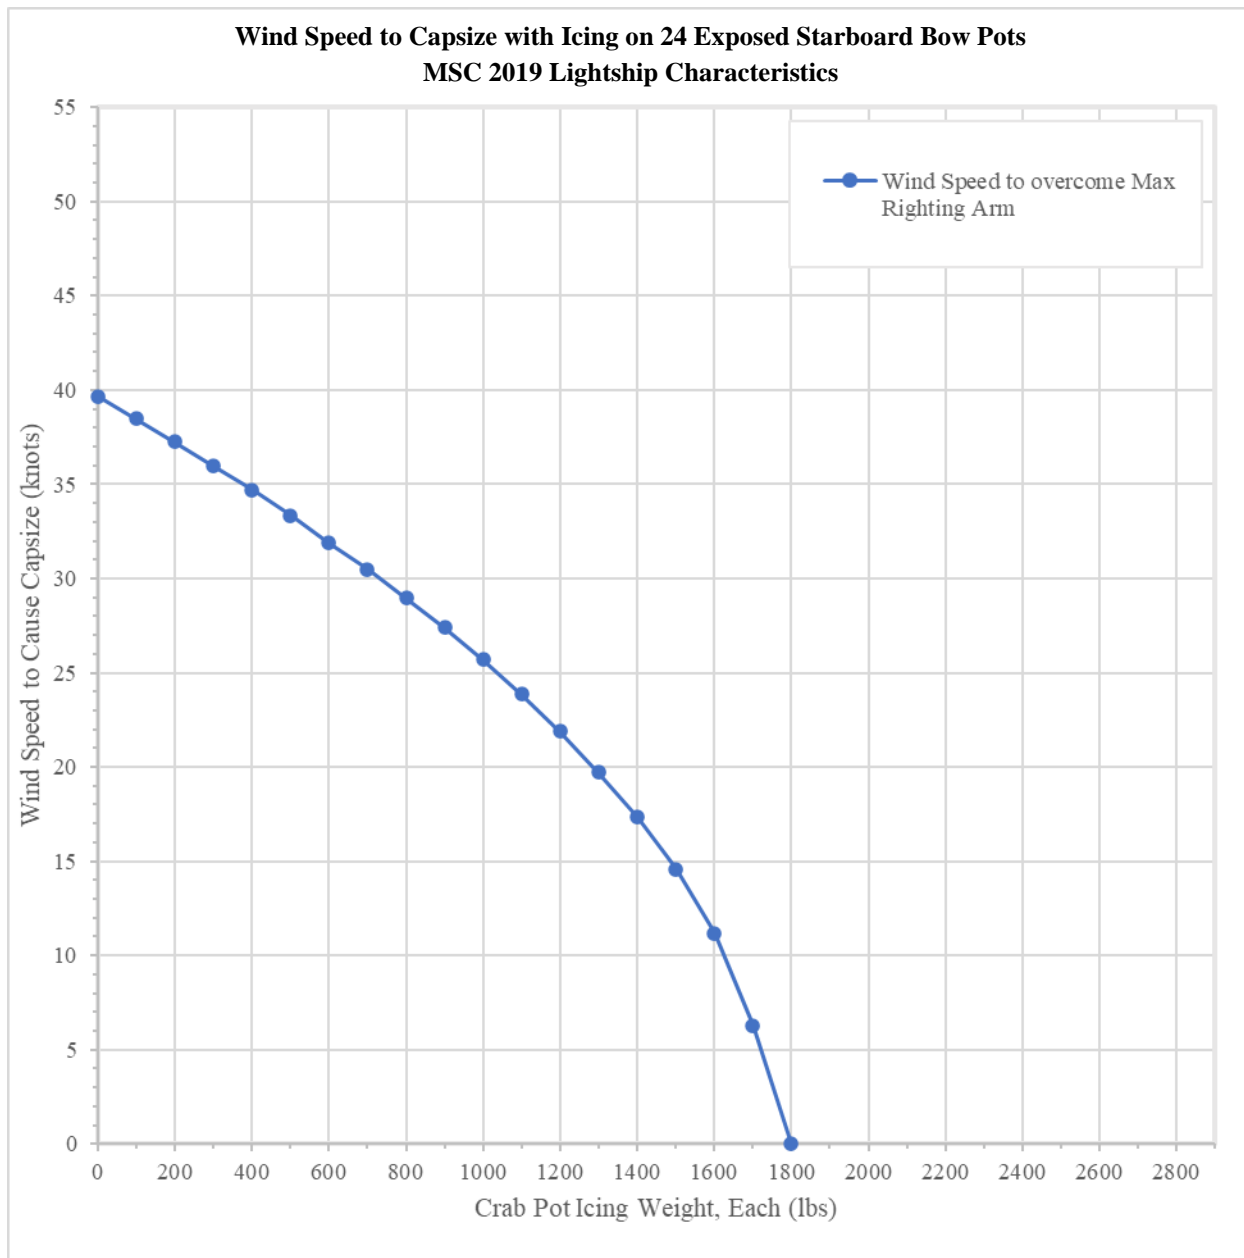
Figure 9: Wind speed to cause capsize vs. crab pot icing weight on 24 exposed starboard bow pots using MSC's calculated lightship characteristics from Mr. Culver's 2019 stability test notes

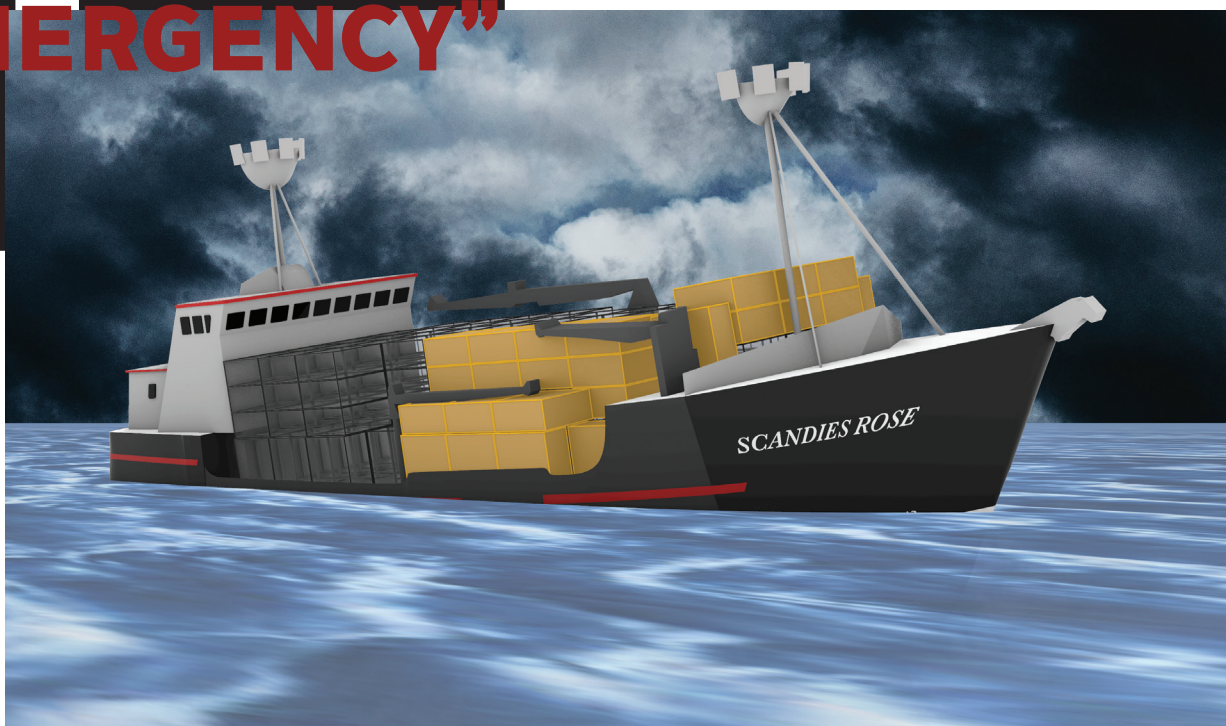
This *Scandies Rose* computer model depicts the vessel with a 10 degree list to starboard, listing into a 60-70 knot wind on the starboard bow, from sometime after 8PM on the night of the accident. The orange rectangles are crab pots on the starboard side that had begun to accumulate ice as the voyage continued. Source: USCG Marine Safety Center.

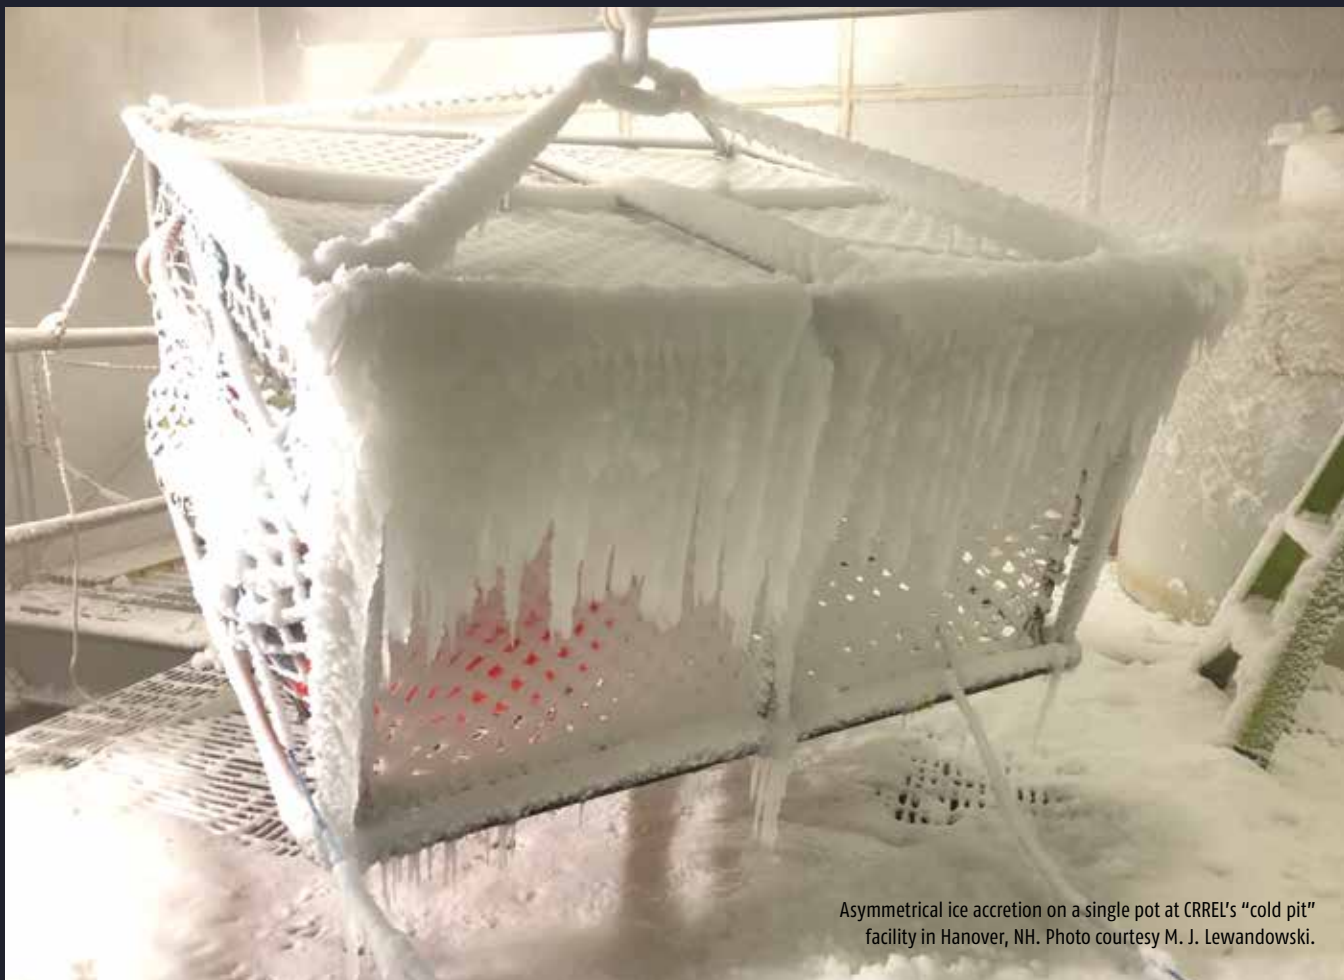
Asymmetrical ice accretion on a single pot at CRREL's "cold pit" facility in Hanover, NH. Photo courtesy M. J. Lewandowski.

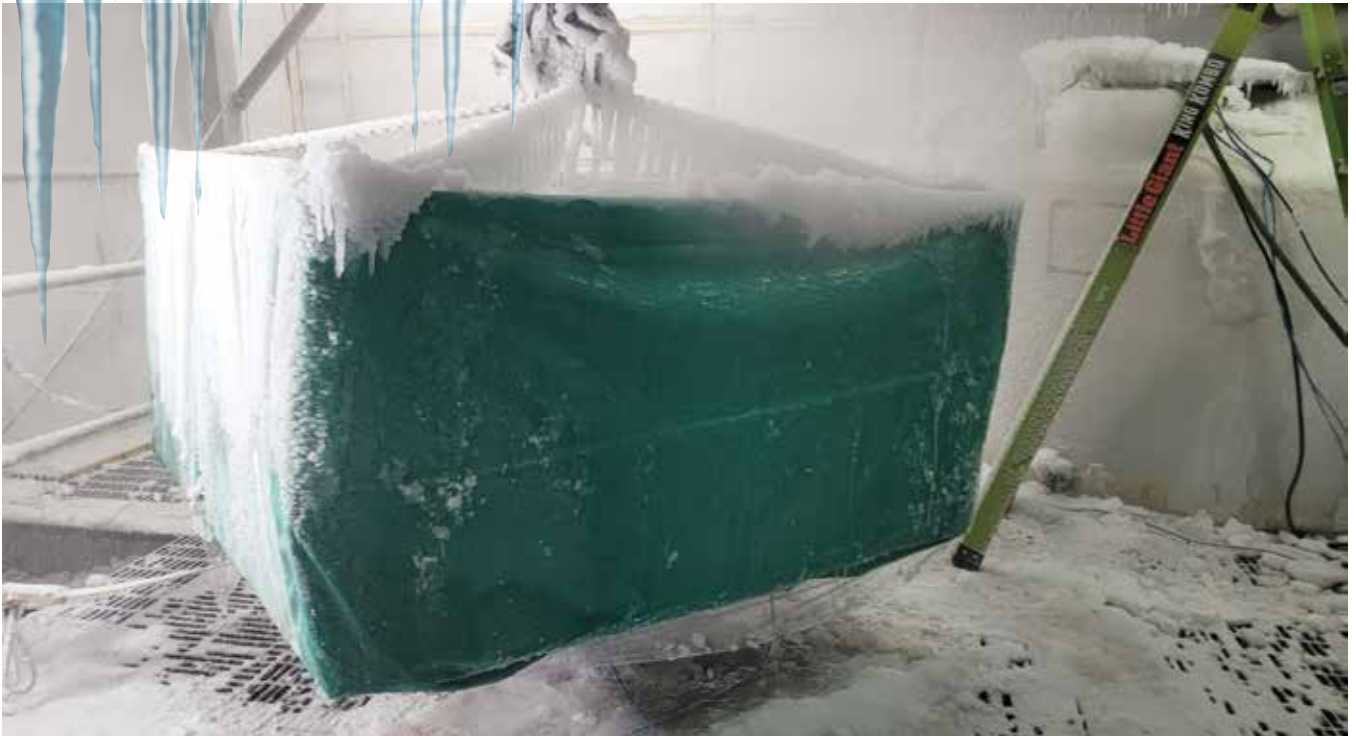
Crab pot under weatherproof tarp to demonstrate ice accretion on covered pots. Photo courtesy Michael Wurl.

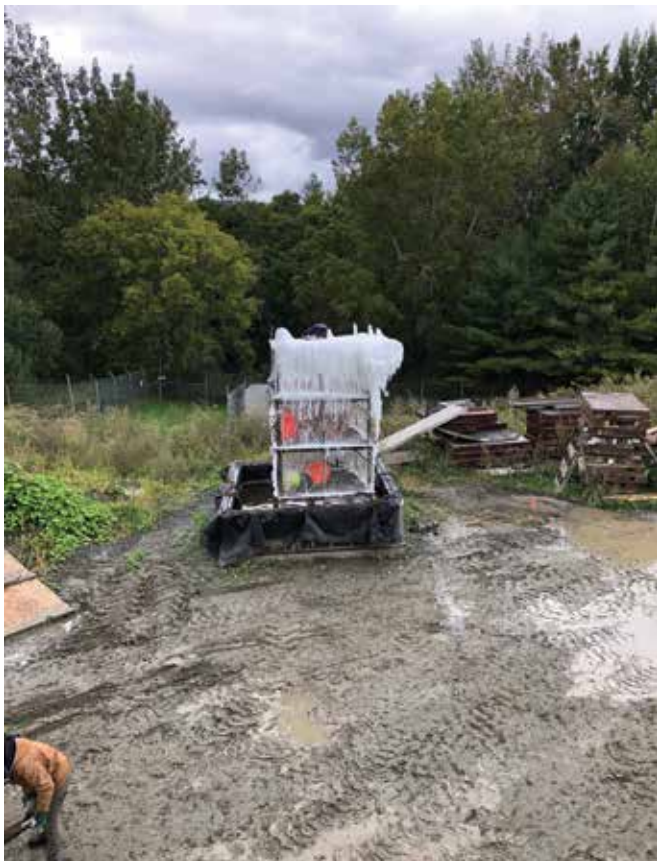
Ice accretion as viewed from 45 ft., part of the tests carried out at CRREL's facilities. Photo courtesy M. J. Lewandowski
