NATIONAL TRANSPORTATION SAFETY BOARD

Search and Rescue Transponder (SART)

Specialist's Factual Report

Location: Port Fourchon, LA
Date: April 13, 2021
Type: Liftboat
Registration: *SeacorPower*
Owner: Falcon Global Offshore, LLC.
Operator: Seacor Marine, LLC.
NTSB Number: DCA21MM024

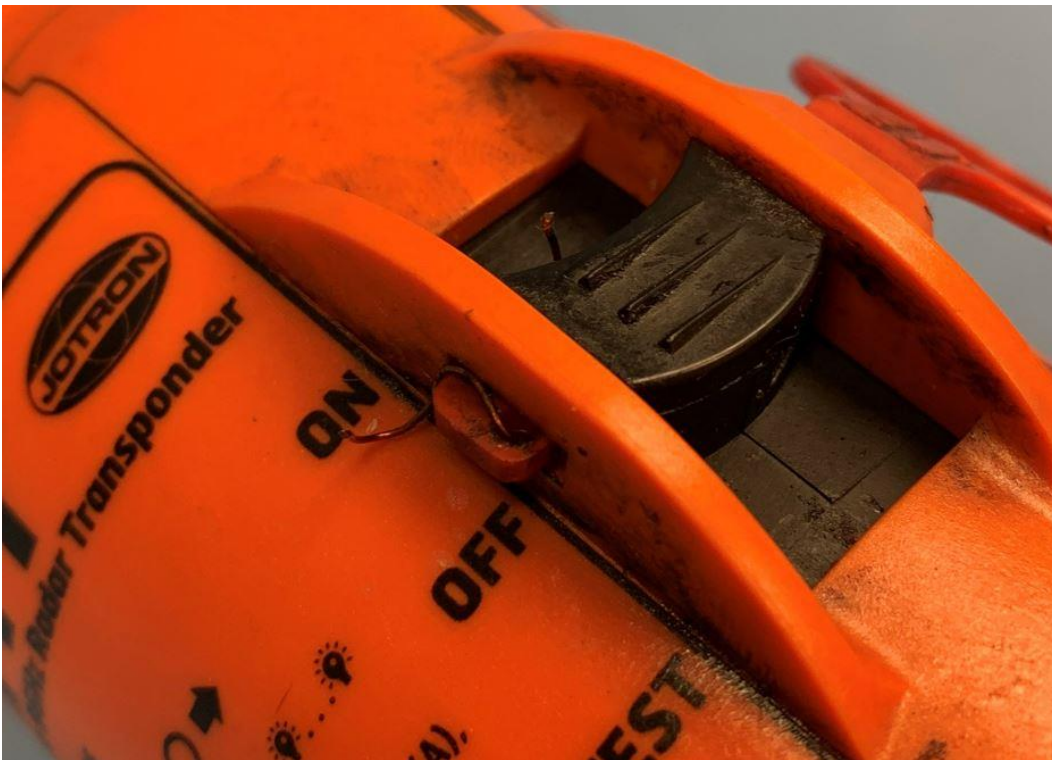
The device's activation pin was examined. The device activation pin's safety wire was broken (figure 2), indicating that the device had been activated at some time.

Figure 2. Broken safety wire (copper color) indicating the device had been activated at some time.

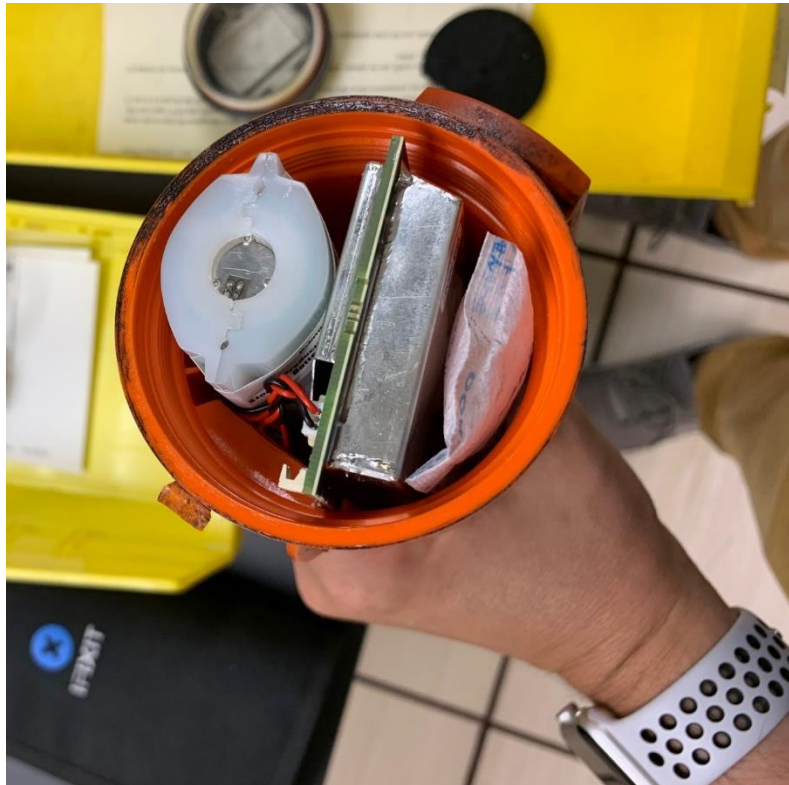
The device's component seal (sticker) affixed at the interface between the bottom lid and the housing was examined and was not broken. The device was then disassembled by unscrewing the bottom lid from the housing. During this process, it was noted that the component seal did not break and the seal slipped around the bottom lid as it was unscrewed. Figure 3 is a photograph of the device after the bottom lid had been removed. All internal components were as described. The desiccant packs were removed and found to be dry. The internal components were examined and found to be dry with no evidence of water intrusion, or corrosion.

Figure 3. Internal component view during inspection.

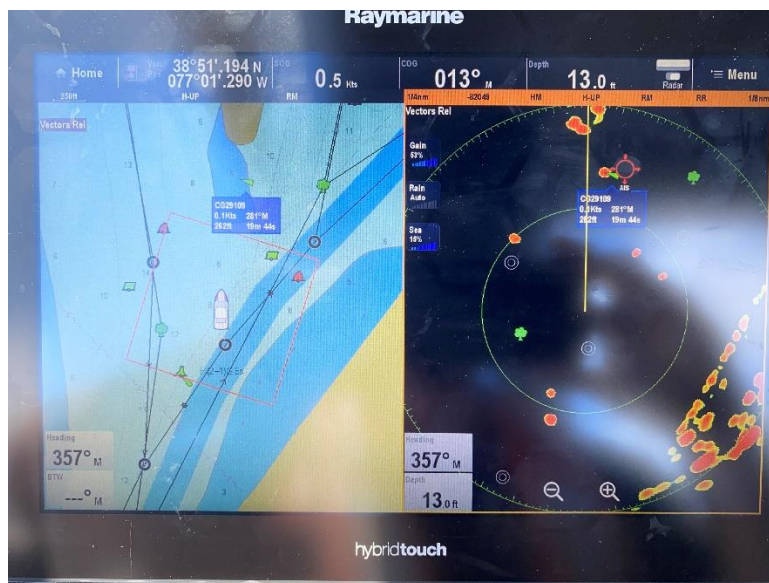
Upon activation a low volume tone from the SART was audible. The SART's red LED light flashed approximately twice per second. At test point 1 (range inside 0.5 nm), the SART was not observed by vessel RX or the *John Glenn*. The height and orientation of the SART was changed at test point 1. The SART was activated at various heights, including mounted to a bosun's pole approximately 9 feet above the water. The SART was held in these orientations for approximately 5 minutes. Figure 5 is a picture of the SINS-2 radar display on the USCG 29' Vessel RX. Figure 6 is a picture of the Garmin radar display on the *John Glenn*. Note that range in figure 5 was set to 1/8 nautical miles (NM) and the range in figure 6 was set to 2 NM.

Figure 5. Display from Vessel RX at range rings of 1/8 NM. The location of Vessel TX is shown on the radar display as target "CG29109".

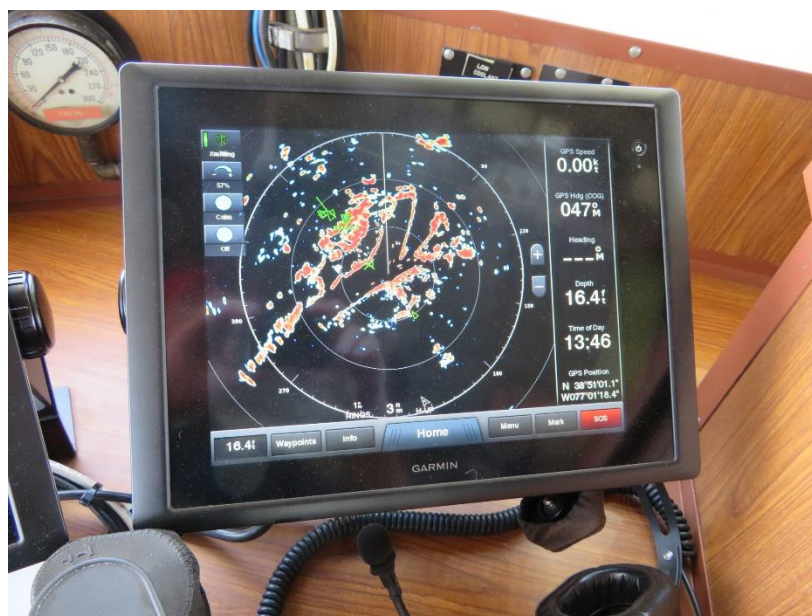
Figure 6. Display from the *John Glenn* at range rings of 2 NM.

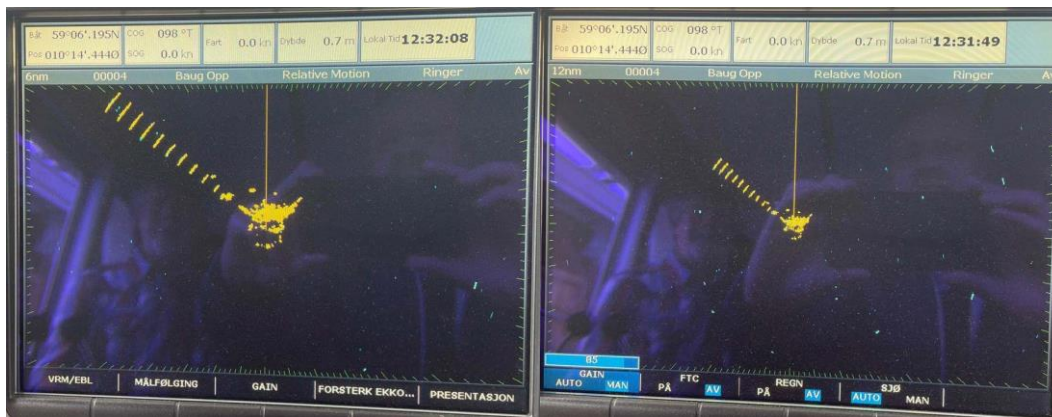
The manufacturer then conducted the OTW portion of testing in Sandefjordsfjorden. The OTW testing consisted of operating the beacon at two different land locations with a stationary X-band radar system at a third, stationary location. In "position A" the SART was placed approximately 1 NM from the stationary X-band system, and in "position B" the SART was placed approximately 0.4 NM from the X-band system. The stationary X-band system was a Raymarine E120 4kW X-band system. One NSIA representative and the representative from Seacor Marine was placed on the stationary X-band radar system, and another NSIA representative was placed with the beacon. In both positions the beacon was activated and the radar image response was documented at the stationary system. The height of the beacon at "position A" was approximately 1 meter above sea level and the height of the beacon at "position B" was approximately 3 meters above sea level. Figure 9 shows the radar's display at "Position A" and figure 10 shows the radar's display at "position B." Both displays showed the appropriate response at the given distance (a 12 striped converging cone at distances > 1 NM and a series of 12 concentric circles at a position < 0.4 NM).

Figure 9. The radar's display at "position A." Note one image shows the radar display's range rings set to 6 NM, and the other to 12 NM.

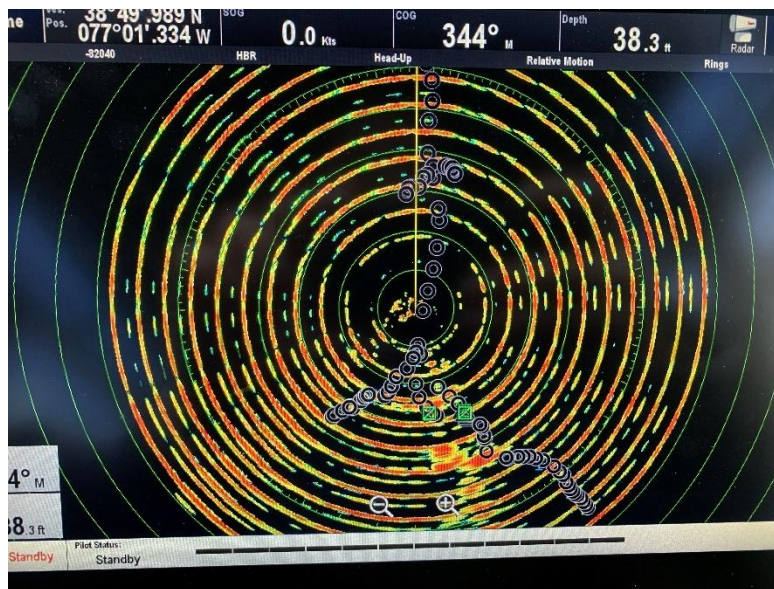
In early December 2021, the NTSB revisited the USCG station to conduct pierside testing of the SART after it had been returned from Norway. Prior to the test, the beacon was disassembled, the battery tested, and the unit tested for activation and the device returned to service. The pierside test consisted of setting the SART on a tripod in a field next to a USCG 29-foot boat with a SINS-2 electronics package. The SART was placed on the tripod in proper orientation with the antenna side toward the sky, and no obstructions between the SART antenna and the 29-foot boat's radome. The SART was activated. After activation, range rings of the radar were set to 6NM, gain and clutter settings were adjusted on the radar system. Shortly after activation, the radar system displayed the appropriate response for a closely placed SART (concentric rings appear on the display). Figure 11 is a photograph of the radar display during pierside testing. In the photo, the radar displays rings were set to a range of greater than 12 NM. Additionally, the gain and clutter settings were changed, and variants of the same pattern were detected on the radar display. The range remained set at greater than 12 NM. Figure 12 is a photograph of the radar display with gain and clutter settings changed.

Figure 11. A picture of the display of the pierside radar system with the range rings set to > 12 NM and the gain and clutter settings adjusted to maximize the return of the SART system.

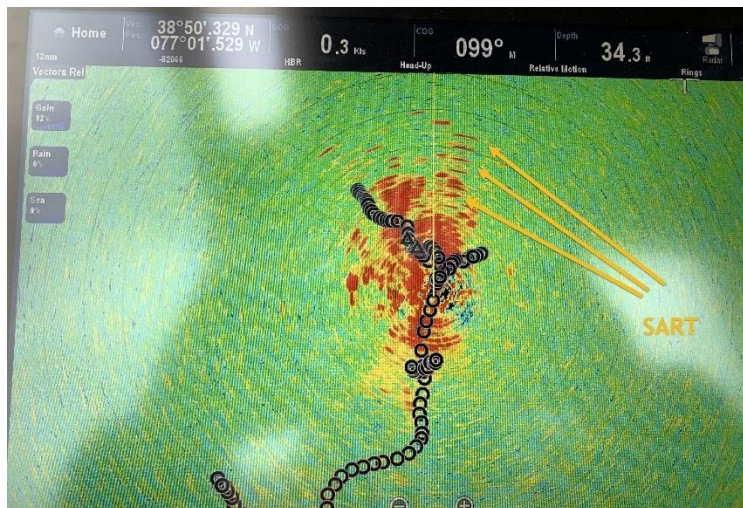
high gain settings, with the range set properly, was the SART able to be received at distances further than 0.4 NM in this particular location. A picture of the radar display at this time is shown in figure 14.

Figure 14. A picture of the radar display of the USCG vessel's radar display detecting the SART at a range greater than 0.4 NM and with the gain setting adjusted to 92%. The SART return has been annotated in yellow.

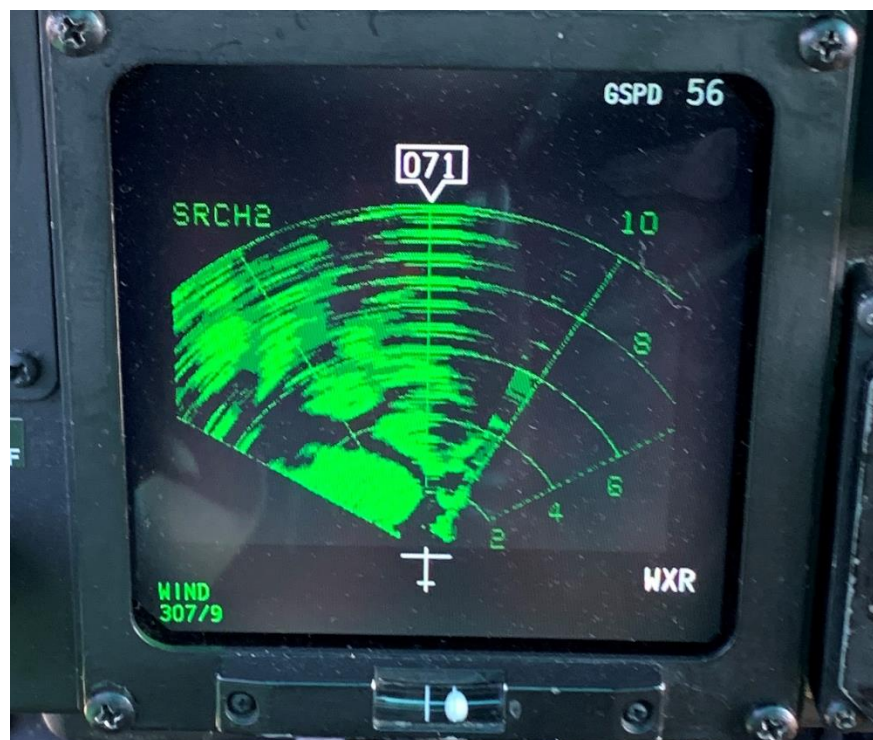
For safety reasons, the USCG aircrew was specifically briefed on the operation and best practices to detect the SART beacon. A set of specific test points were designed to maximize operational safety of the helicopter and the chance of a successful reception of the beacon. These cards were supplied to the USCG aircrew prior to the test and were briefed prior to the flight by NTSB personnel. The SART beacon was placed on a tripod approximately 3 m above sea level, with the antenna facing skyward. The USCG helicopter flew the test points as described on the test cards and was able to successfully receive the beacon. The test cards are attached to this report as Attachment 6. Figure 15 is a photo of the MH-65C's radar display showing a successful reception of the beacon. Note that the RDR-1300C radar system is forward looking, and is unable to display concentric rings displayed from an activated SART at close ranges.

Figure 15. A picture of the MH-65C's RDR-1300C radar display when receiving the SART.
