## **MARINE SAFETY ALERT**

### **Remain Upright by Fully Understanding Vessel Stability**

## Improving Fishing Vessel Stability

### **SCANDIES ROSE Stability Analysis with Asymmetric Crab Pot Icing**

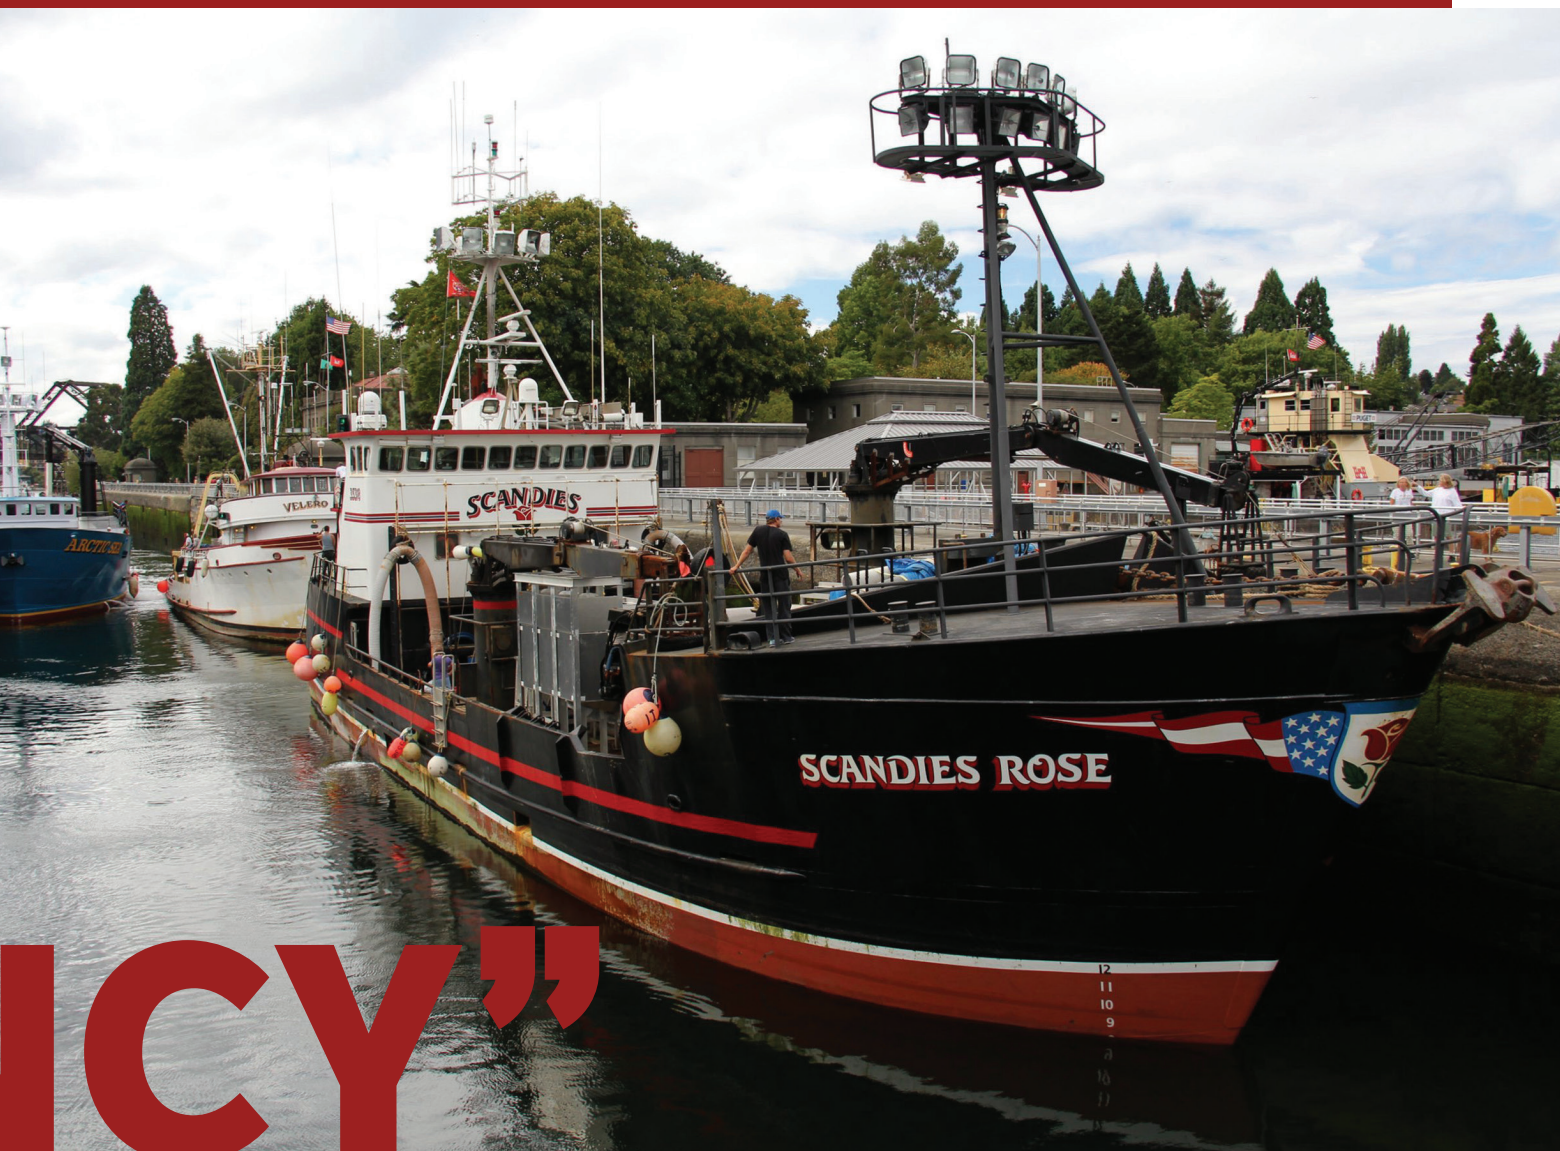
The crab fishing vessel  
*Scandies Rose* sank near  
Sutwik Island, AL on  
December 31, 2019.

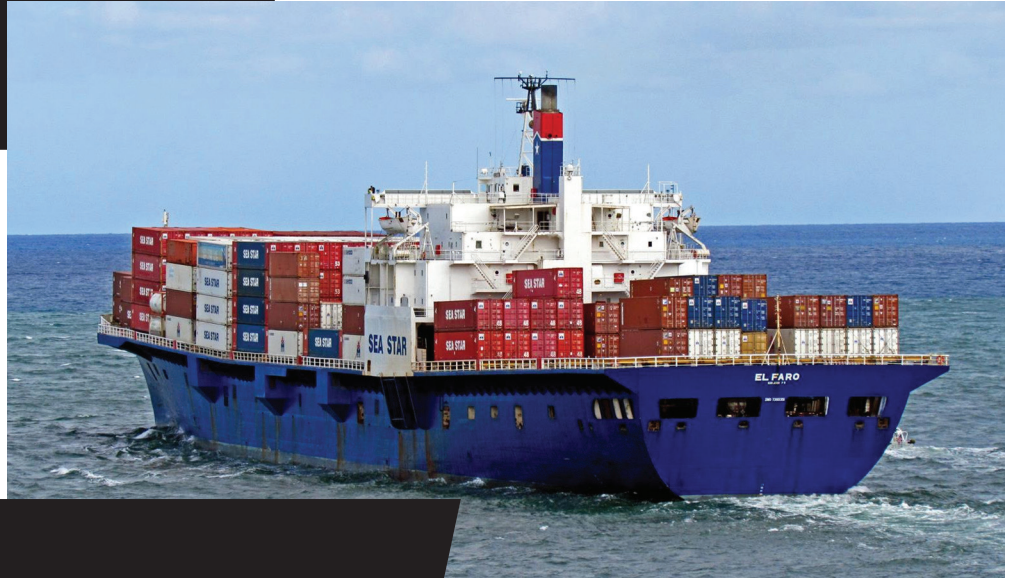
*El Faro* sank in the Atlantic on October 1, 2015, east of the southern Bahamas Island Chain.

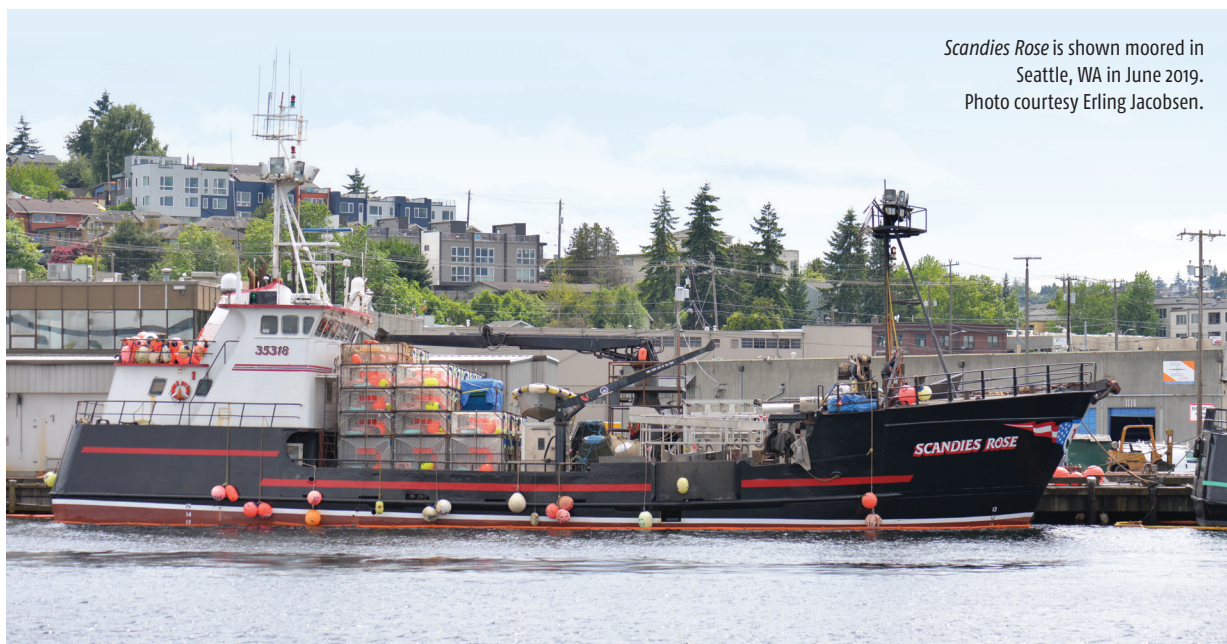
*Scandies Rose* is shown moored in Seattle, WA in June 2019. Photo courtesy Erling Jacobsen.

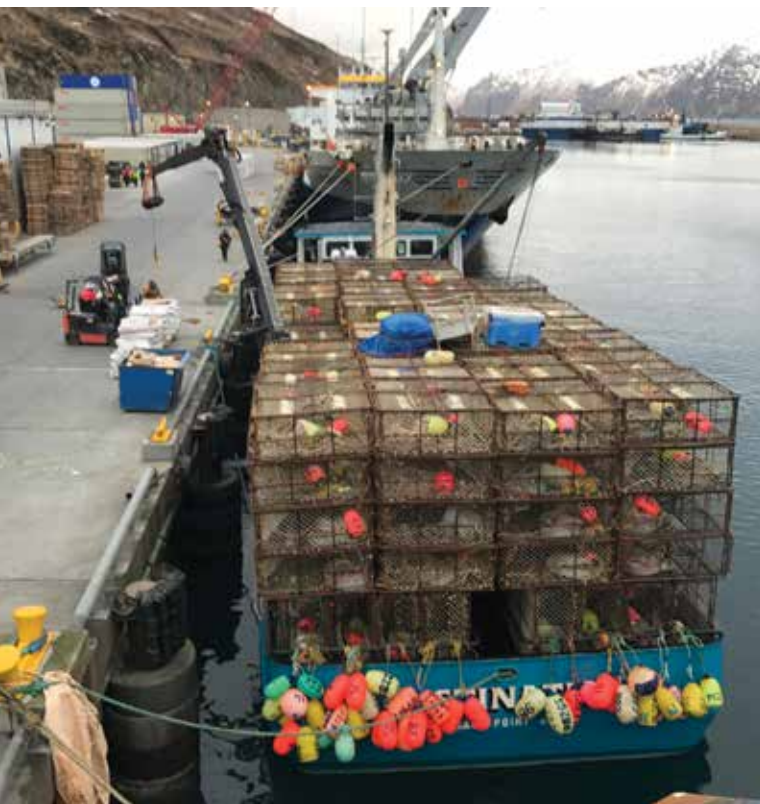
Alaska crabber with pots stacked.  
Photo courtesy Coast Guard Marine  
Board of Investigation.

heading to the shelter of Sutwik Island, the vessel suddenly capsized. Could this list to starboard and the ice accretion on the pots on that side have been the culprits?

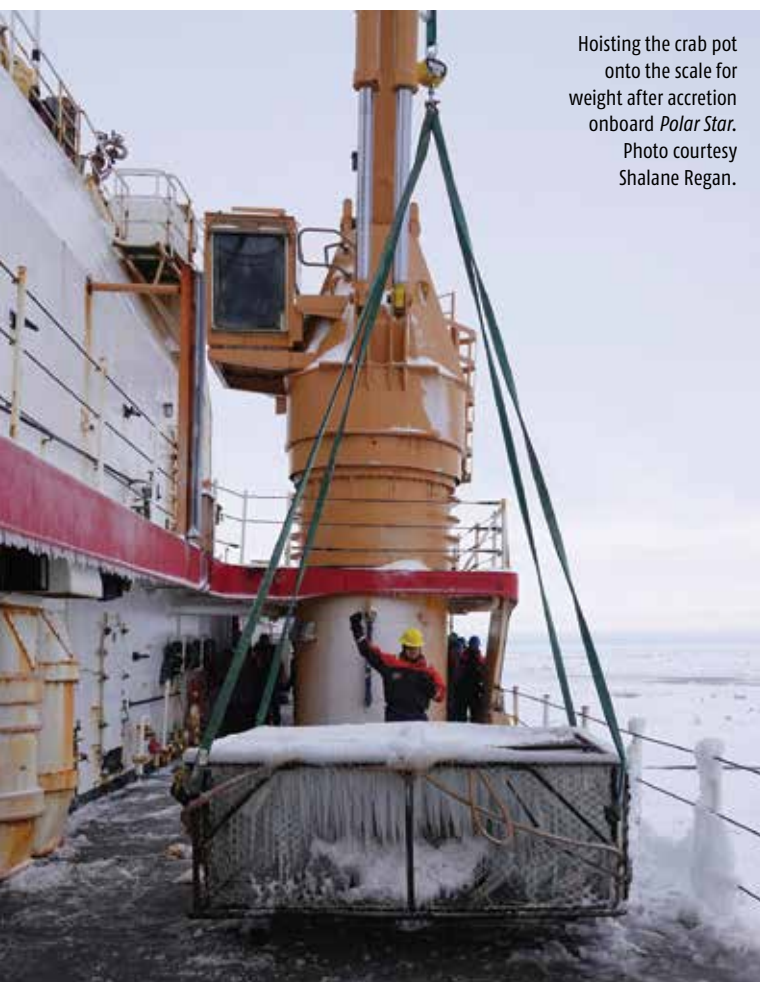
Hoisting the crab pot  
onto the scale for  
weight after accretion  
onboard *Polar Star*.  
Photo courtesy  
Shalane Regan.

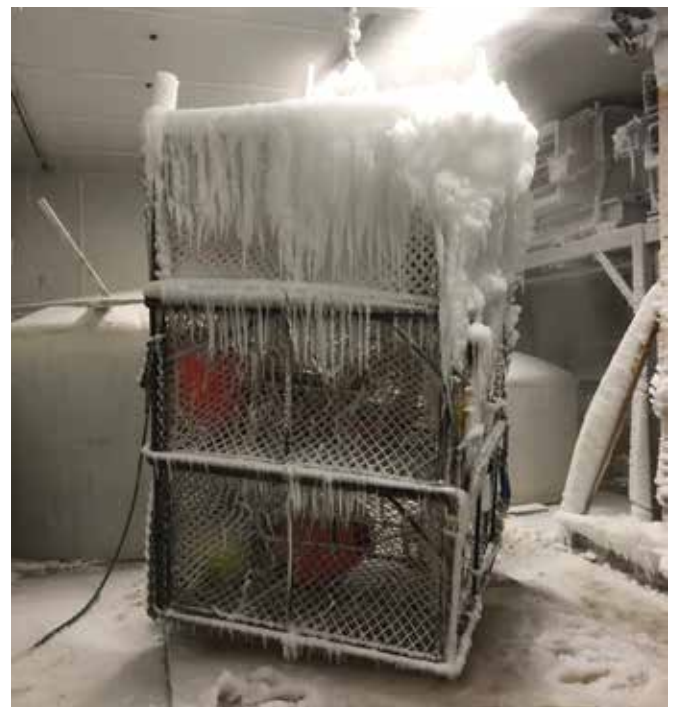
The MBI had concerns about how mariners commonly estimated ice accretion in terms of inches. To address this, after two of the last tests, the researchers placed the three-high stack 45 ft. from an elevated stand to simulate the vantage point that the two *Scandies Rose* survivors had from the wheelhouse, before the accident. Without a reference point, accurately estimating the ice thickness on any point of the distant pot(s) is very difficult. From the wheelhouse, the ice that appears to be only inches thick may actually be much thicker, and large areas of the pot stack are not visible, such as the area forward of the stack of pots.

The materiel evaluation facility test chamber at CRREL in Hanover, NH, showing a 3-pot stack and oscillating spray nozzle. Photo courtesy M. J. Lewandowski.
